PHOTOGRAPHIC INTELLIGENCE REPORT

CHIN-HSIEN SUPPLY DEPOT PAN-LA-SHAN NW, CHINA

CIA/PIR 63050

DATE MAY 1966

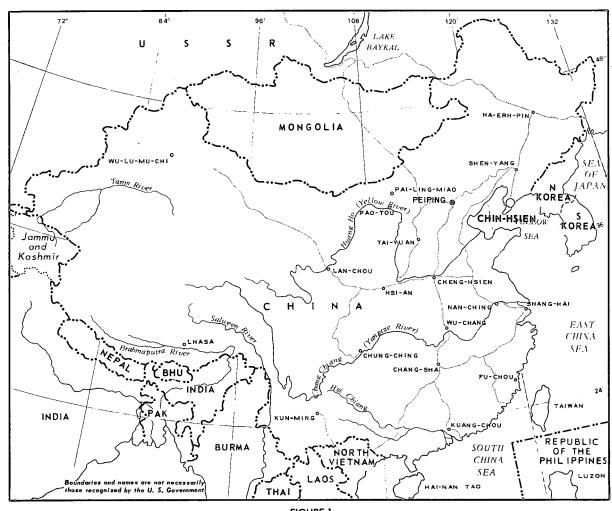
FIGURE 1.

CIA IMAGERY ANALYSIS DIVISION	CIA/PIR-63050	
CHIN-HSIEN SUPPLY DEPOT PAN-LA-SHAN	NW, CHINA	
A previously identified storage facility is locally 121-46-40E, 5 nautical miles (nm) northeast of Chine northwest of the village of Pan-la-shan, China (Figure 12) aerial photographic coverage of the area has established date as sometime between	-hsien and 0.7 nm ure 1). Early	
Storage		
Facilities in the storage area include 7 gable-buildings of various sizes, 1 administration/support storage areas (Figure 3) and 2 small support building long storage buildings (Buildings 1-4, Figure 4) is sections by what appear to be firewalls. Separate essection are located along the southeast side of the northeasterly section of Building 2 has been construgiving the roof a stepped appearance. The 6 dormer were seen on the roofs of each of these buildings that are no longer visible on photography of roofs of two of the buildings appeared to be undergoon the photography.	building, 2 open- ngs. Each of the 4 divided into 3 equal entrances for each buildings. The most acted at a lower level, ventilators which
